**PROACTIVE INDOOR AIR QUALITY  
REPORT  
MBIT**

**Test Date: September 26, 2018**

**Middle Bucks Institute of Technology  
2740 Old York Road  
Jamison, PA 18929**

**November, 2018**

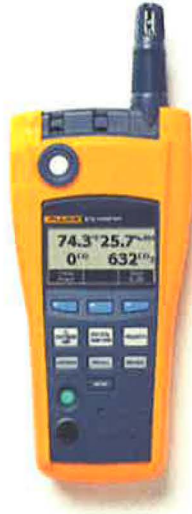
**FLUKE 975 AIR MONITOR**

Temperature and relative humidity readings were obtained using a calibrated, hand-held, Fluke 975 air meter. This data should be considered a “snapshot” of conditions identified on the test date due to the small sample size.

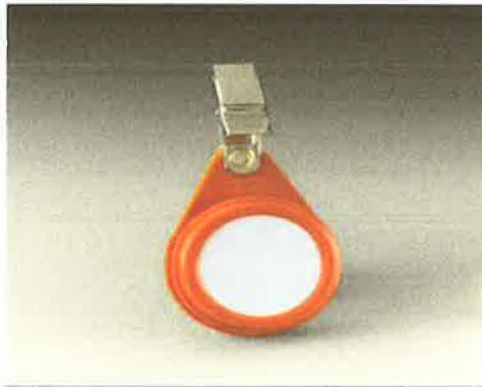
## **ORGANIC VAPOR MONITOR PHOTO**

On September 26, 2018, passive Organic Vapor Monitors (OVMs) were placed in the Cosmetology Area (Rooms 102 & 103). The sampling locations inside the building were selected due to the amount and types of chemicals used in these areas. Both monitors were exposed to the ambient air and left in place for a sampling period of 330 minutes.

The sample from Room 102 had a Total Hydrocarbon level of <math><0.803\text{ ppm}</math> and Room 103 had a level of 1.05 ppm. The higher level in Room 103 was due to the hairspray. The airborne chemicals measured in both test locations are not an issue from an IAQ perspective.

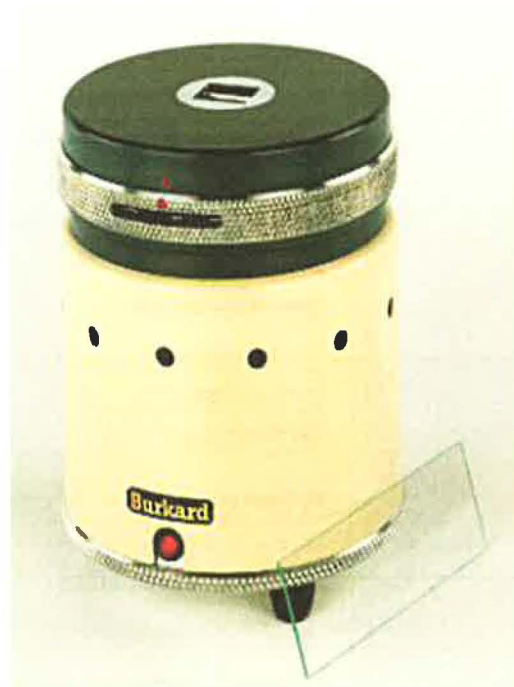
### **Burkard Spore Trap Photo**

The Burkard is a portable, volumetric air sampler used for collecting airborne particles directly onto glass slides. The glass slides used in the Burkard Spore Trap were prepared using a mixed cellulose ester (MCE) gel. They were supplied to EnviraHealth by a certified (EMLAP) environmental microbiological laboratory.

Ambient air was drawn into the sampler at a flow rate of 10 liters/minute (LPM). The total volume of air for each test sample was ninety (90) liters (Flow Rate - 10 LPM X 9 Minutes per Sample).
